MM 1700-1
July, 1976

STANDARDIZED TEST PROCEDURE FOR MIDWAY'S PROCESSOR BOARDS

MIDWAY MFG. CO.

FLOW CHART OF TROUBLESHOOTING
PROCEDURE

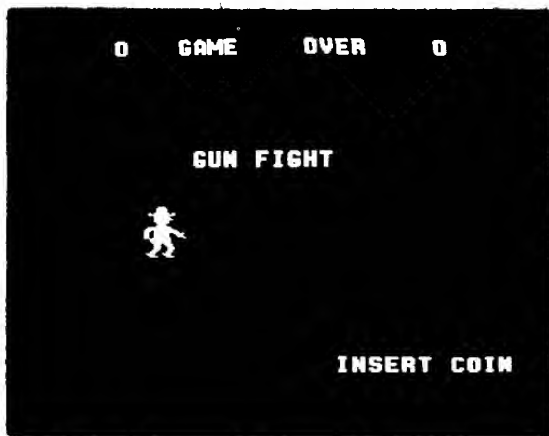
Figure 3.2-1 Good Picture with Good Program

By good picture is meant here a clear screen with the words "Game Over" and "O" on either side of it. In the case of a good Mother Board the words "Gun Fight" would be seen followed by the Cowboy coming in, shooting a bullet downwards, and walking back. During this process the words "Insert Coin" would appear on the lower right hand side temporarily (Figure 3.2-1). If all or part of this is bad it could most likely be a program problem.

Try changing the PROMS one at a time till it is rectified. If the program seems alright and the Cowboy shape or movement is bad go to Case D.
